A common issue that occurs with the Shaker rail-and-stile router bit set is that the design or upper part of the rails protrudes or recedes more than necessary, which can trick the user into thinking that the blades were not machined properly. This is not a manufacturing defect and can be resolved by either removing or adding a thin shim or two at the correct location on the arbor.

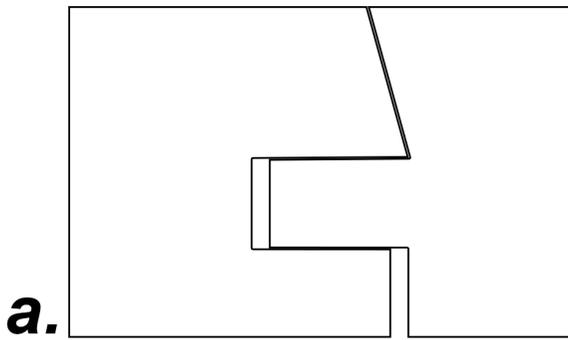
In diagram *a*, one or two shims should be removed from the shim location on the bit.

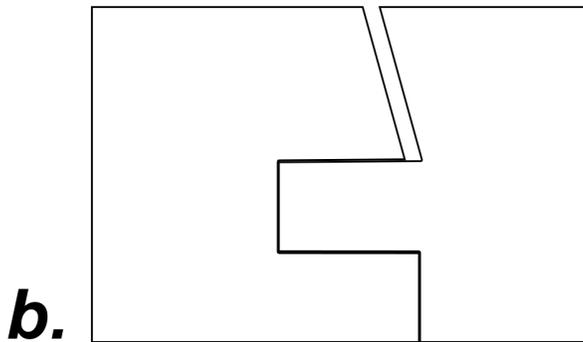
In diagram *b*, one or two shims should be added to the shim location.

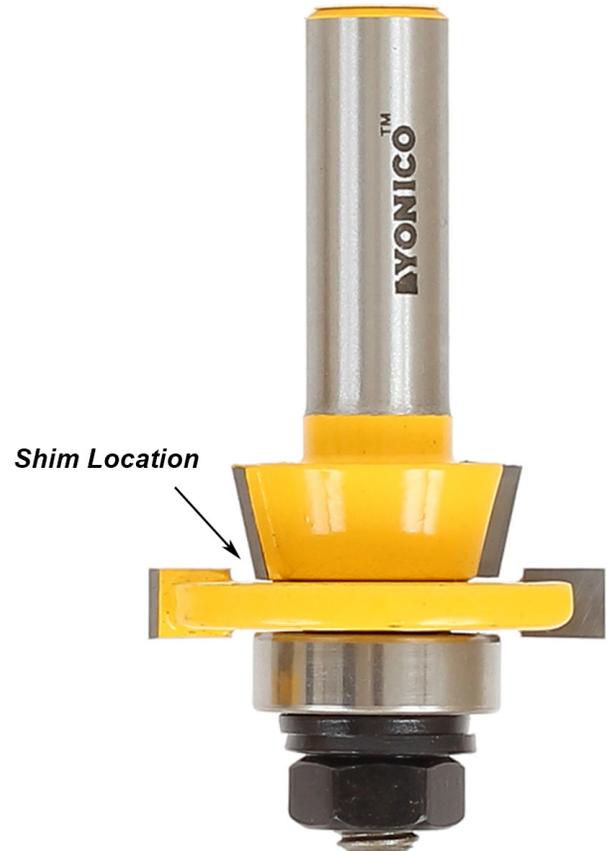
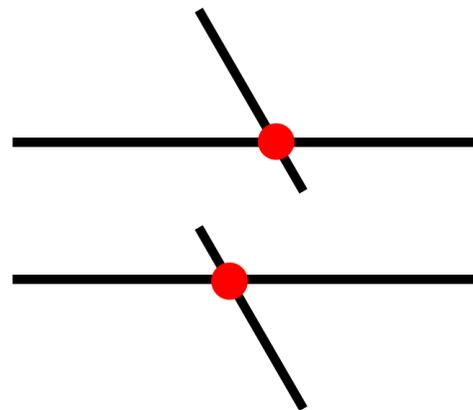
The reason for this is that when a diagonal line intersects a horizontal line, the intersecting point can be moved left or right by simply raising or lowering the diagonal line without actually moving it left or right. You can see how this works in the illustration to the right.

The same holds true for the Shaker router bit set, which has a diagonal blade. If the diagonal blade were to be separated or made closer to the slot cutter, the same effect will occur and the blade will cut deeper or shallower on the upper part of the rails.
